TECHNICAL REPORT • MAY 2014

# Virgin River Ecohydrological Assessment—Flood-Scour Analysis, Vegetation Mapping, and Restoration Suitability

PREPARED FOR  
Walton Family Foundation  
Freshwater Initiative  
P.O. Box 2030  
Bentonville, AR 72712

PREPARED BY  
Stillwater Sciences  
2855 Telegraph Avenue, Suite 400  
Berkeley, CA 94705

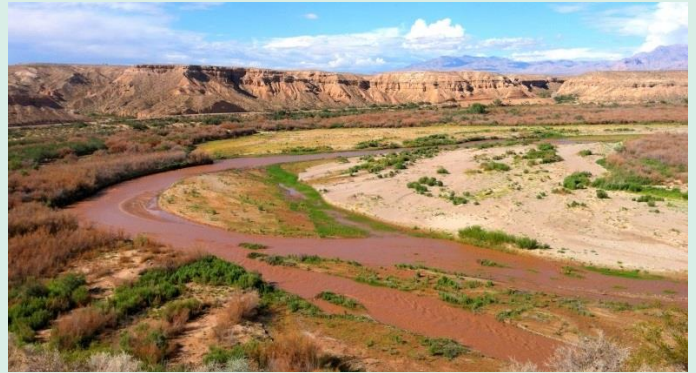
*Top right:* Photograph of lower Virgin River recently scoured during the December 2010 flood and partially bordered by defoliated tamarisk (at left); downstream of Littlefield, Arizona (photo by D. Orr)

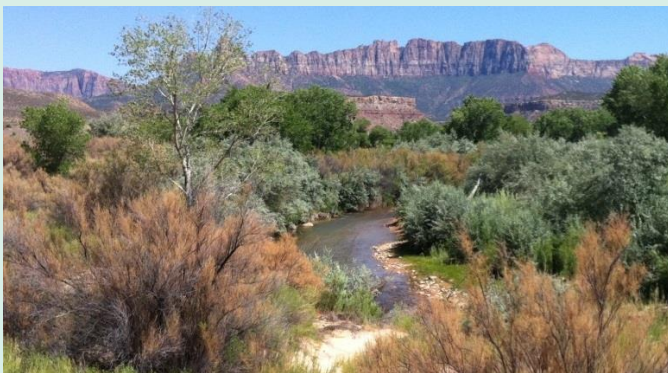
*Bottom left:* Photograph of upper Virgin River recently flooded in December 2010 and bordered by defoliated tamarisk (in foreground), Russian olive (in middle ground), and cottonwood (in background); downstream of Rockville, Utah (photo by G. Leverich, Stillwater Sciences)

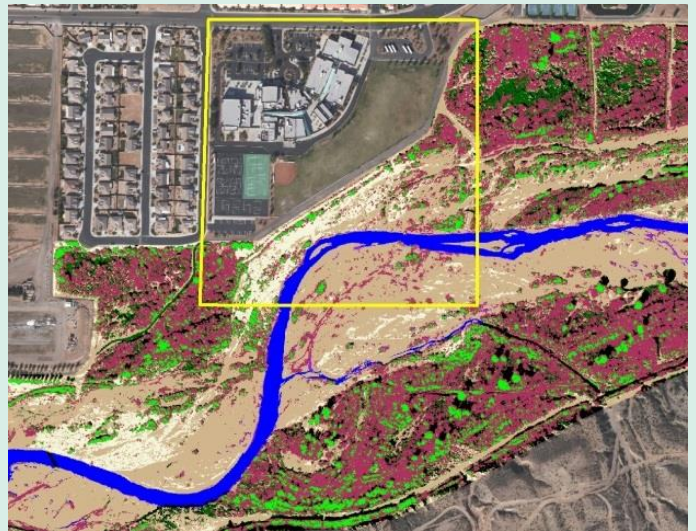
*Bottom right:* Vegetation-classification mapping produced by Utah State University’s RS/GIS Laboratory depicting dominate riparian vegetation types near Mesquite, Nevada following the December 2010 flood event.

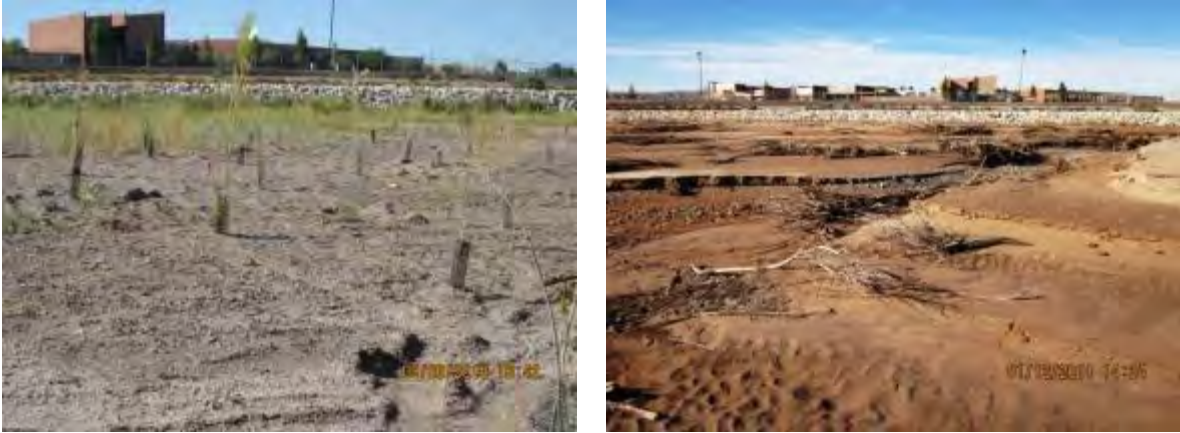
**Figure 2.** Views of the Hughes Middle School restoration site in the City of Mesquite, Nevada before (left photo) and after (right photo) the December 2010 flood that scoured much of the channel, including the restoration efforts. Project implemented by City of Mesquite, Partners in Conservation, and U.C. Santa Barbara after the 2005 flood event. (Photos by T. Dudley, UCSB)

Tamarisk removal and native vegetation plantings have been implemented by Partners in Conservation at the Hughes Middle School restoration site in Mesquite, Nevada on a regular basis since before the December 2010 flood. However, this flood severely disturbed restoration efforts here as the active channel adjusted abruptly, but not entirely unpredictably (see Figure 2). To aid future planning efforts at the site scale, we refined our Ecohydrological Assessment by including additional environmental factors pertinent to the site. These included soil texture and salinity based on the NRCS soils database, depth to shallow groundwater and in-channel depressions estimated from a relative-elevation surface produced from the November 2011 LiDAR (elevations are shown to be relative to the low-flow water surface in the river channel), changes in vertical elevations of the active river channel associated with the 2005 and 2010 floods (surface differencing of 3 repeat LiDAR datasets taken before and after each event), and vegetation structure and composition based on a combination of the LiDAR-based canopy-height surface, vegetation-classification layer, and field-based surveys (Figure 9). This type of information can feed directly into development of site restoration design and planting plans.

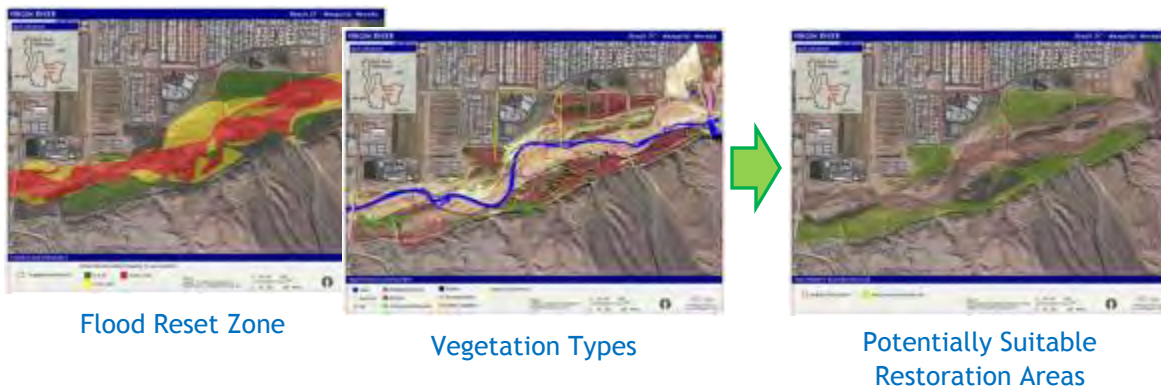
**Figure 6.** Process of the ecohydrological assessment to identify potentially suitable restoration areas along the Virgin River. Example shown above is of the Hughes Middle School restoration project area in Mesquite, Nevada.

Synthesis of these environmental factors was performed in a GIS where areas (polygons) representing potential suitability for active riparian restoration along the entire length of the Virgin River were generated (Figure 6). The potentially suitable restoration areas are shown on the maps in Figures 8.1 through 8.23 (c, d) (see Figure 7 for an index map).

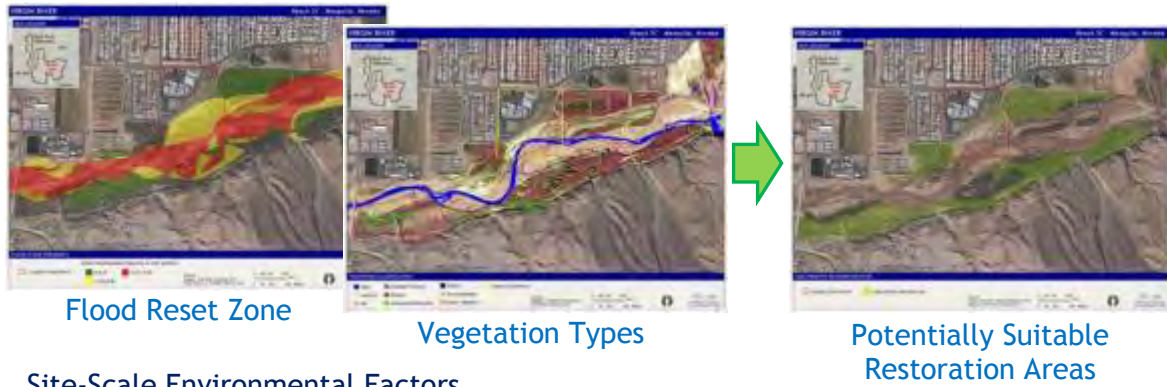
**Figure 9.** Process of refinement of the ecohydrological assessment at the site-scale to prioritize restoration at the Hughes Middle School restoration site in Mesquite, NV.

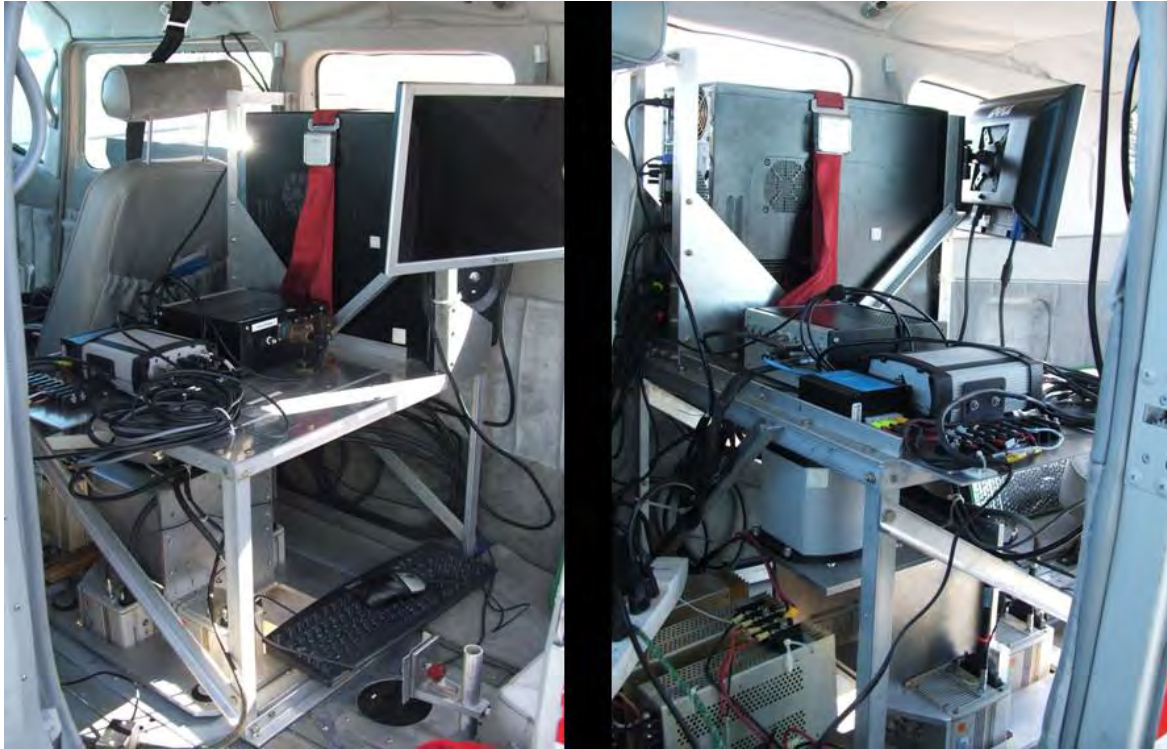
Figure 1. Details of the USU airborne multispectral remote sensing system and LASSI Lidar system installed on the USU Cessna TP206 remote sensing aircraft.

The multispectral portion of the airborne system consisted of three Kodak Megaplug 4.2i digital cameras with interference filters forming spectral bands in the green (0.545-0.555  $\mu\text{m}$ ), red (0.665-0.675  $\mu\text{m}$ ) and near infrared (NIR) (0.790-0.810  $\mu\text{m}$ ) wavelengths. The cameras are mounted along side the Lidar through a porthole in a Cessna TP206 aircraft, dedicated for remote sensing missions (Figure 1). The cameras are controlled through special software using Epix boards in a fast desktop computer, mounted in the equipment rack. The system digital cameras are calibrated against a radiance standard using a method described by Neale and Crowther (1994). On the day of the flight, a standard reflectance panel with known bi-directional properties was set up in a central location to the study area. An Exotech 4-band radiometer was mounted looking down onto the panel from nadir, measuring incoming irradiance at one-minute intervals. This information was used to calculate the reflectance of the pixels in the spectral imagery. The panel was mounted either at the Saint George, Utah airport or the Mesquite, Nevada airport depending on what section of the river was being flown.

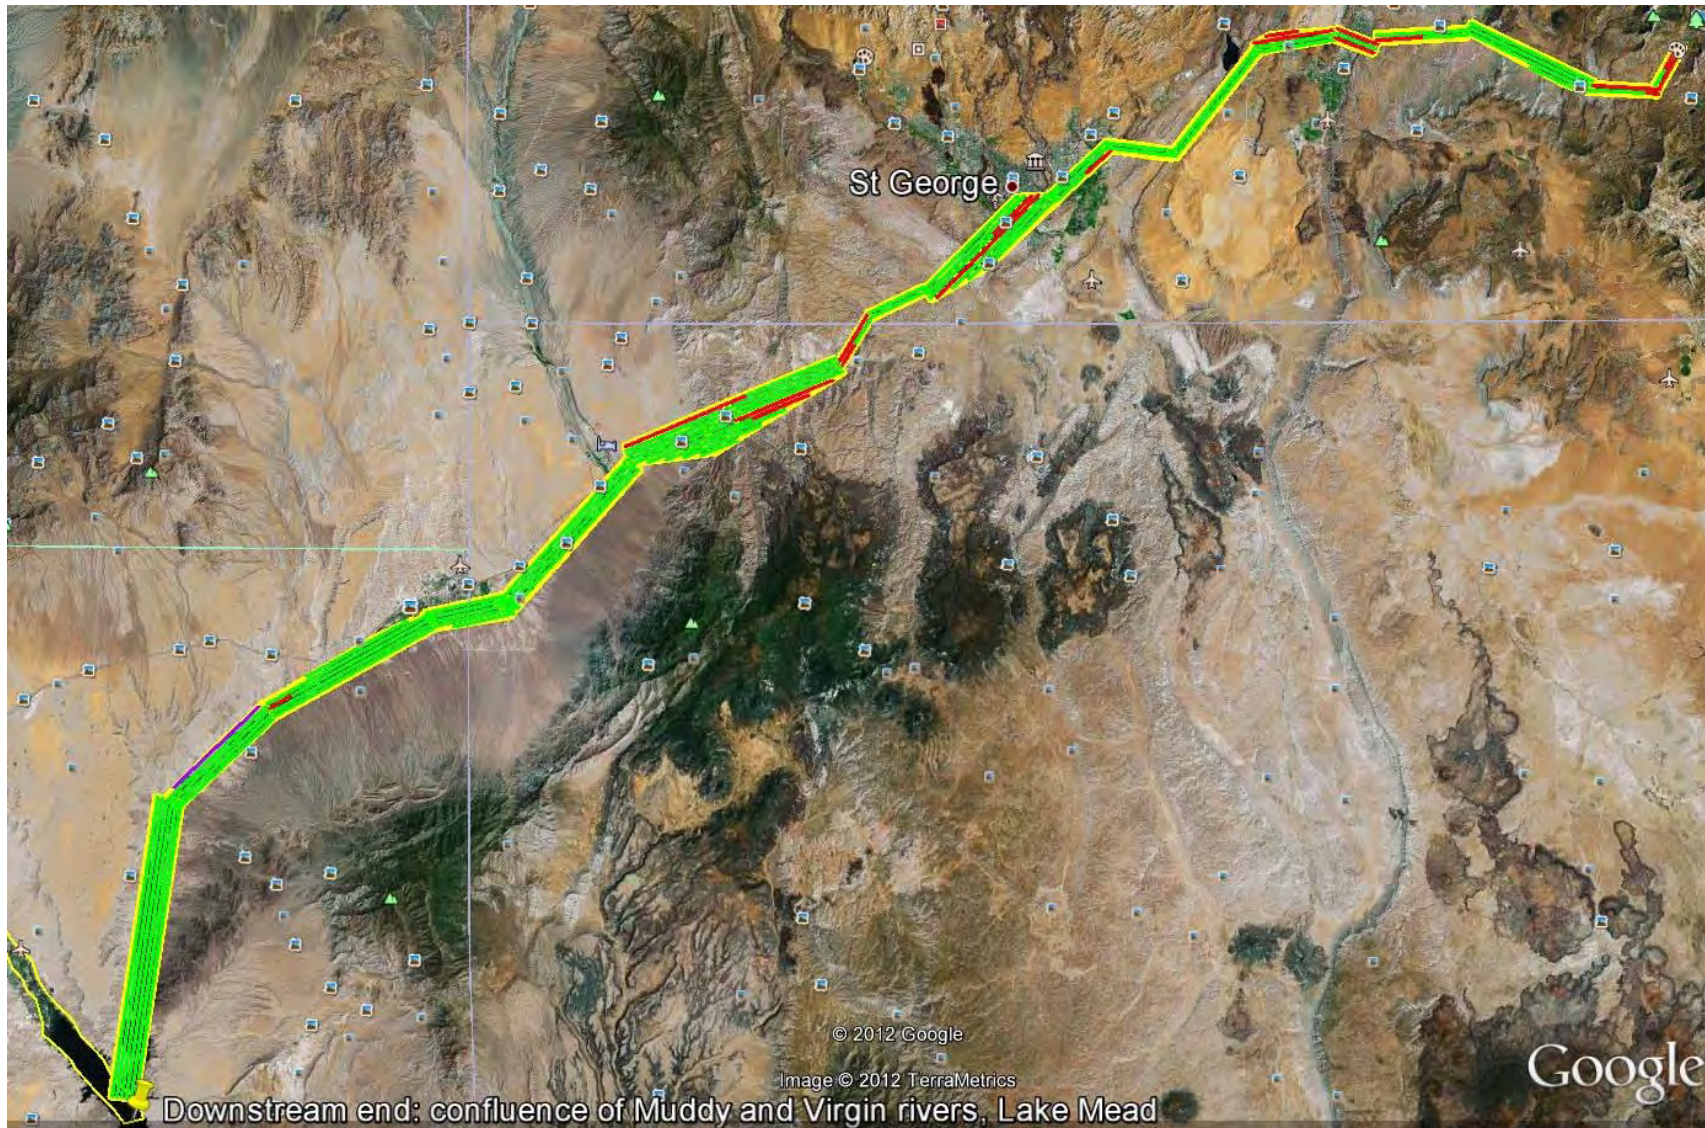
Figure 2. Schematic of the flight lines flown during the data acquisition flights. Red lines indicate missing multispectral imagery.

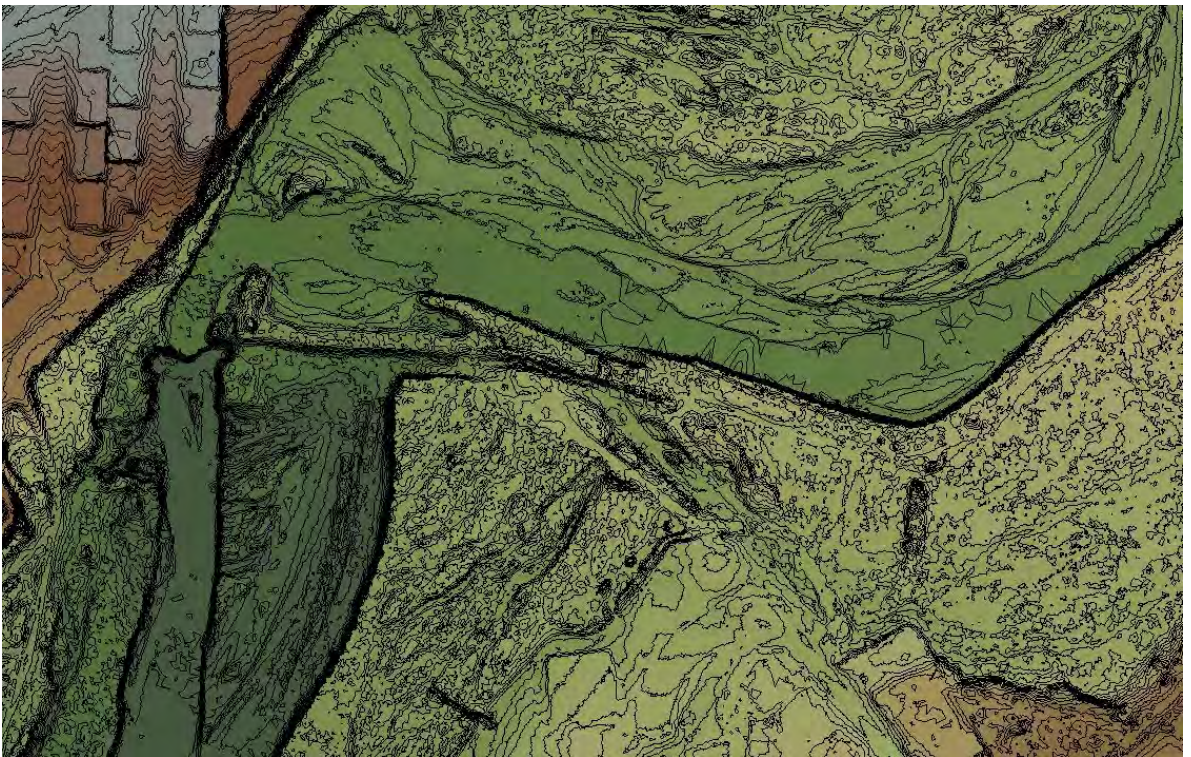
Figure 10 Contour lines (0.2 m) produced from the TIN surface

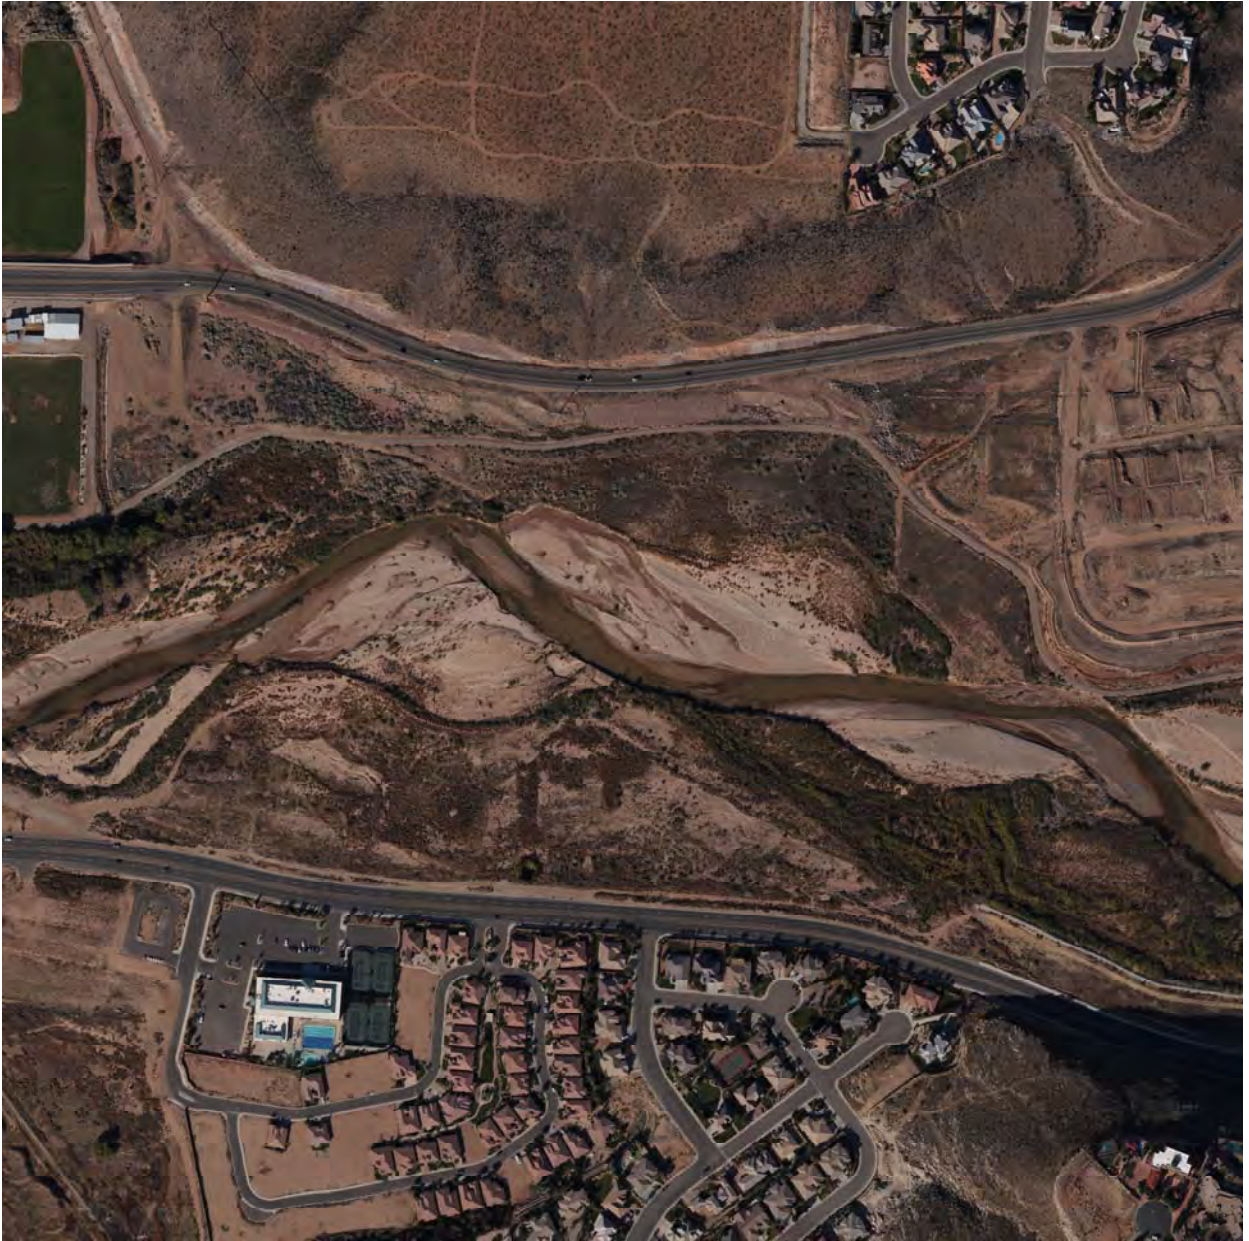
Figure 15 Color digital orthophoto tile of a section of the Virgin River, near Saint George, UT.

A complete set of color digital orthophotos was produced using data from the color digital camera of the LASSI system, corresponding to the Lidar tiles. An example is shown in Figure 15 below.

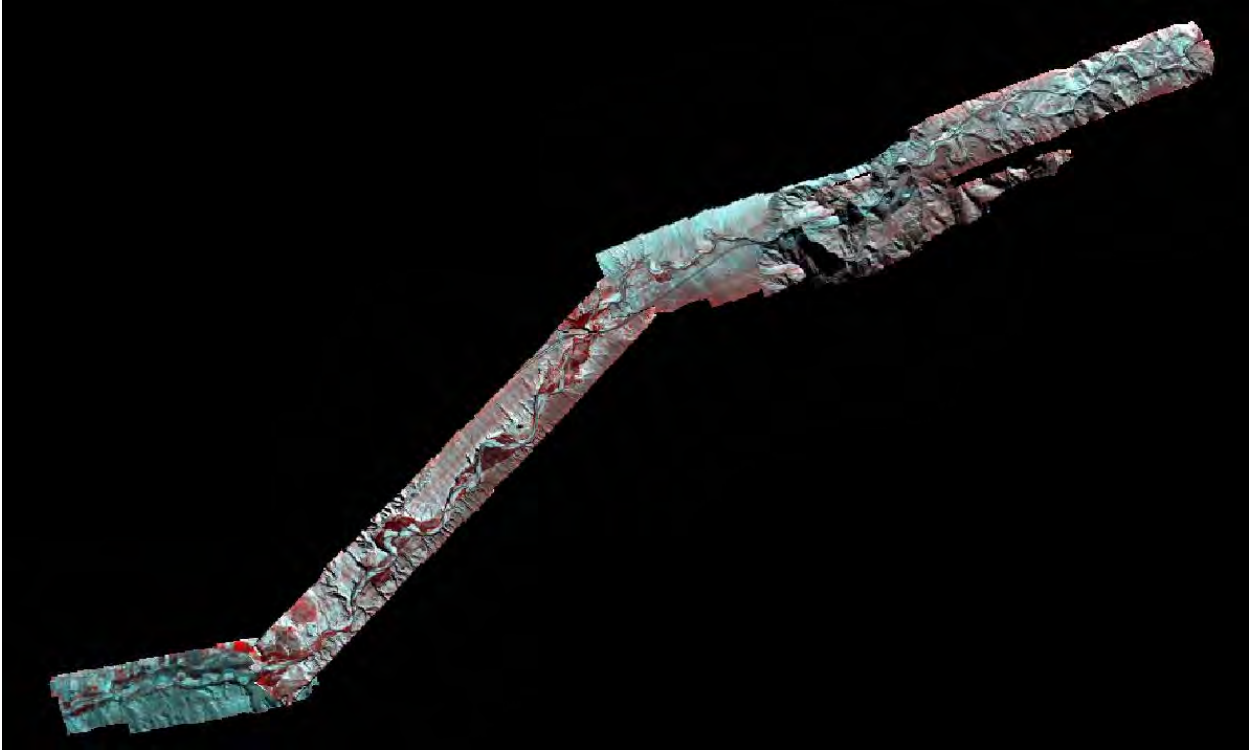
Figure 17 Multispectral orthophoto mosaics for three flight blocks of the Virgin River.

The multispectral digital orthos were produced by flight blocks which are a series of parallel flight lines covering a section of the river and that can be seen in Figure 2. An example of a multispectral mosaic for 3 blocks is shown in Figure 17 below.

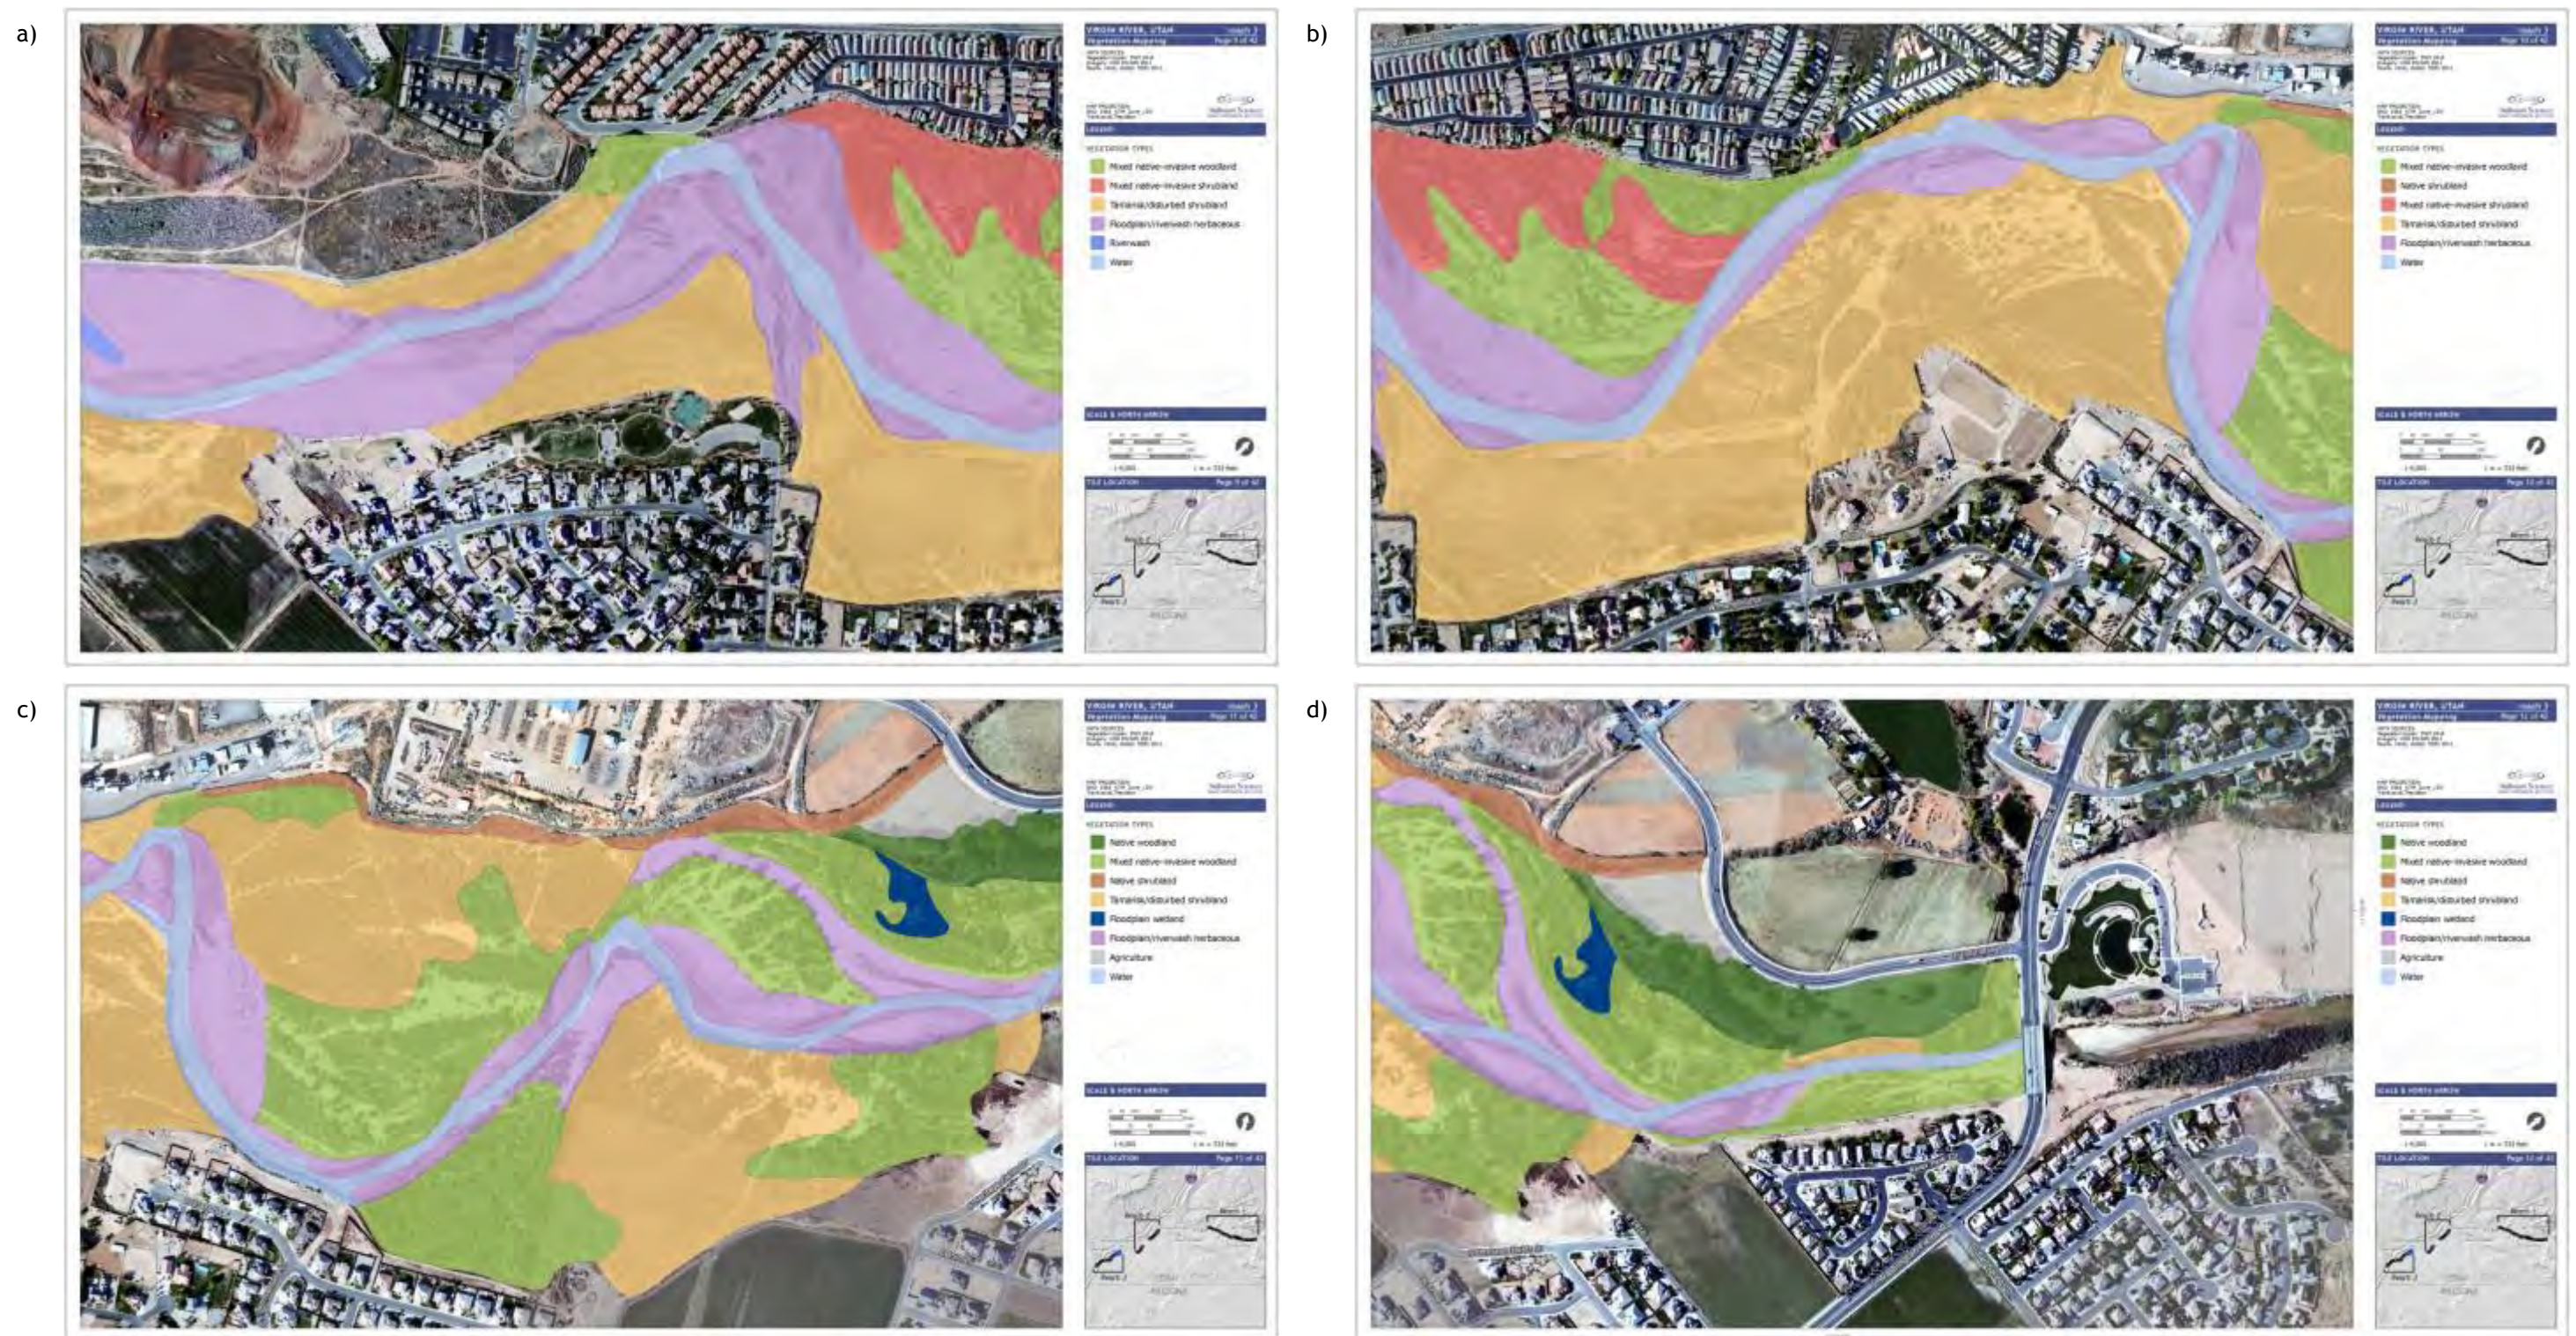
Figure C1.3. Upper Virgin River field-based vegetation mapping for TNC-Utah's Lower Reach near Washington, Utah.
