BUREAU OF LAND MANAGEMENT  
LAS VEGAS FIELD OFFICE

# FINAL REPORT

**RESTORATION OF CRITICAL DESERT TORTOISE HABITAT  
2005-BLM-500-P**

## Upland Restoration in Critical Desert Tortoise Habitat Final Report

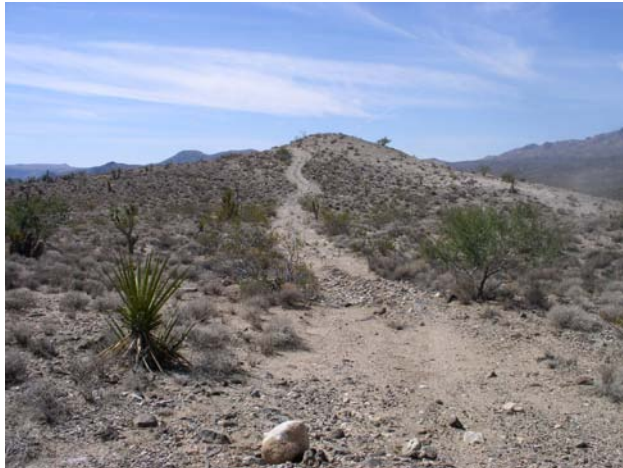
Site PV0906k before restoration treatment

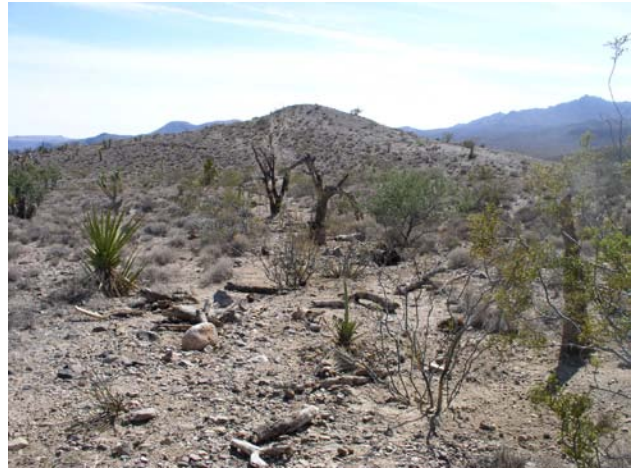
Site PV0906k after restoration treatment

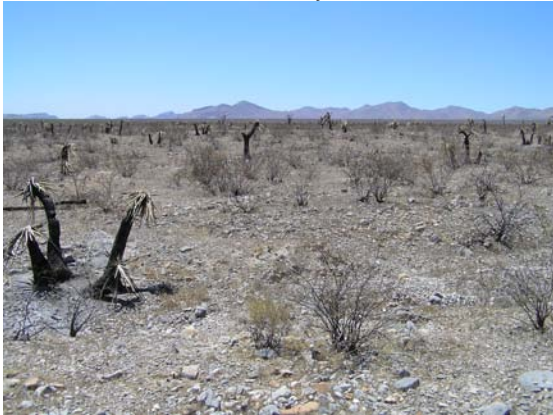
Burned tortoise habitat, Dry Middle

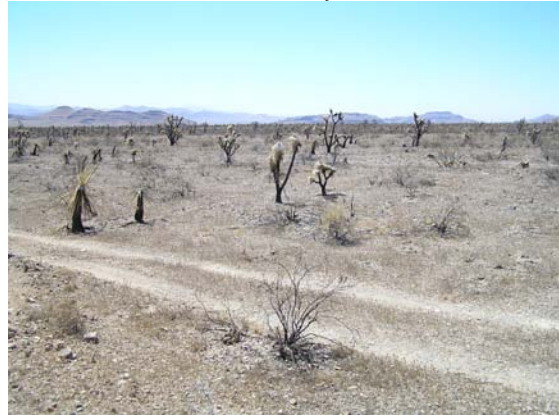
Burned tortoise habitat, Dry Rock

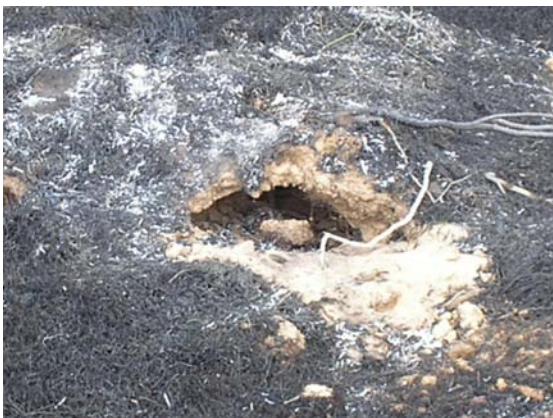
Tortoise burrow surrounded by fire devastation

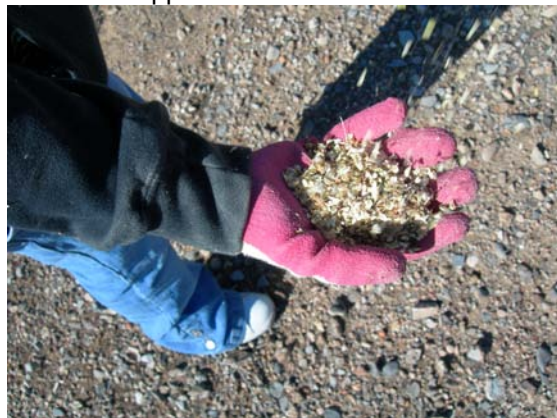
Seed Mix applied to sites

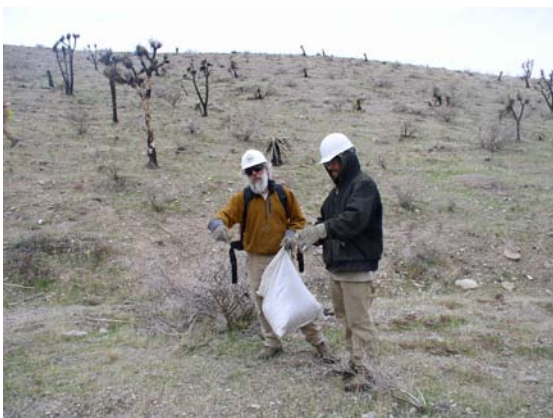
Crews seeding burned tortoise habitat

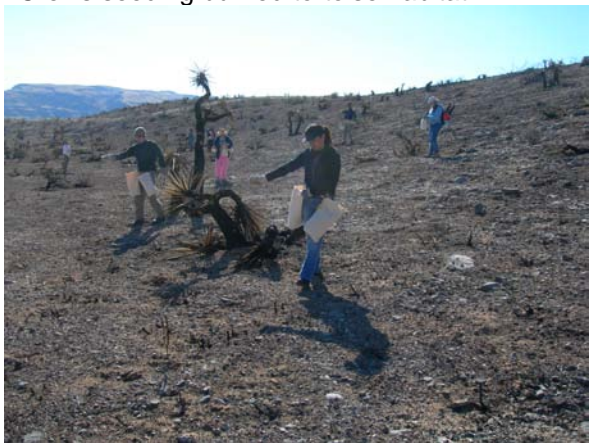
Crews seeding burned tortoise habitat
